An Archaeological Survey
of the townships of Suisnish and South Fearn
plus the surrounding area.

Raasay

Portree Parish
Skye and Lochalsh District, Highland Region

Association of Certificated Field Archaeologists
Occasional Paper No 80

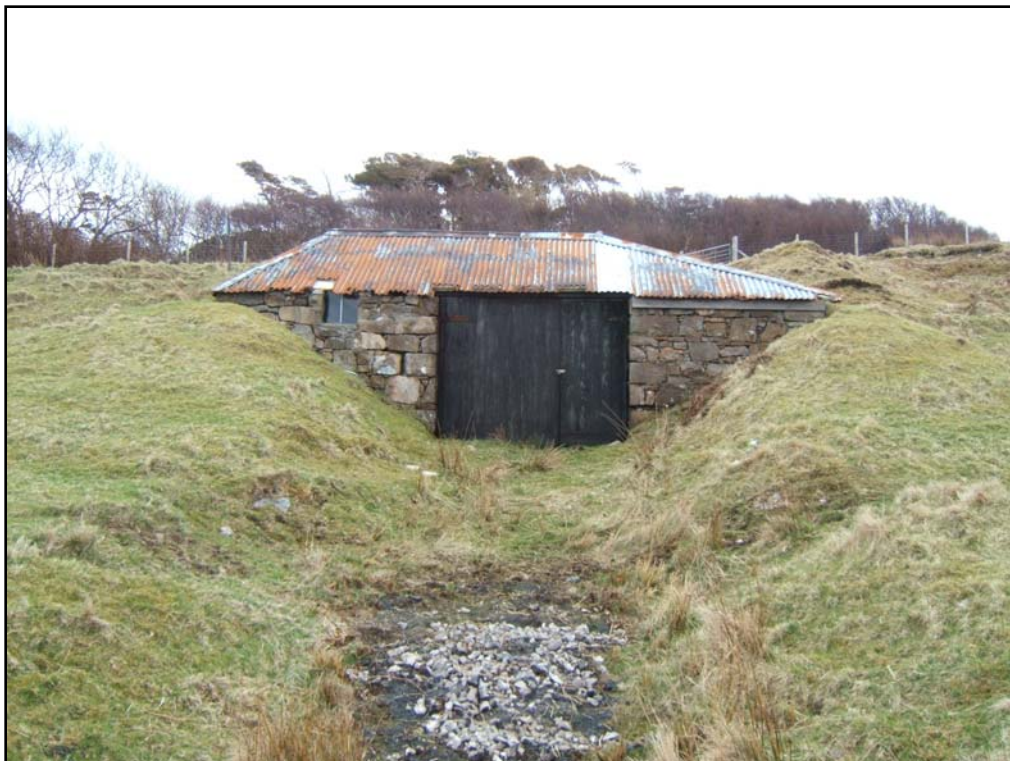
**Feature 6**

An L-shaped stone built boathouse, which is thought to have been built from the remains of an older structure, has been dug into the ground and abuts the road. The structure measures 8m x 9m externally with drystone walling standing to a height of 2m. The structure is roofed with corrugated iron and has a door, 2.40m wide, in the west wall. The ground has been built up on either side of the structure and a slipway running down to the shore has been dug out. The structure is in good condition and is still in use.

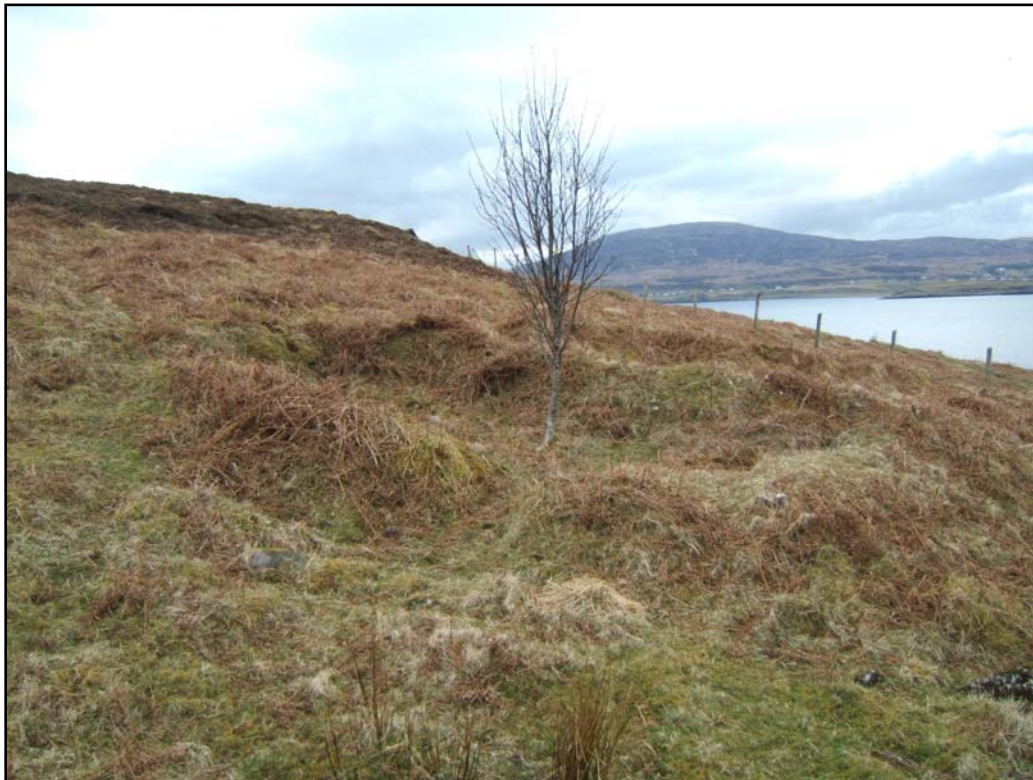
Feature15

Lying not more than 2m to the east of Feature 14 are the low remains of a house lying almost north-south on its long axis and measuring 6.40m x 4m externally. The walling is grass and moss covered of little height and the structure has been scooped into the ground to a depth of 1.50m. Some large stones lie in the interior. There has been an entrance 0.80m wide in the east side. Beside the north end is a levelled, sub-rectangular area with stones as bottoming which may have been a stand for storing peats or a stack stand for crops.

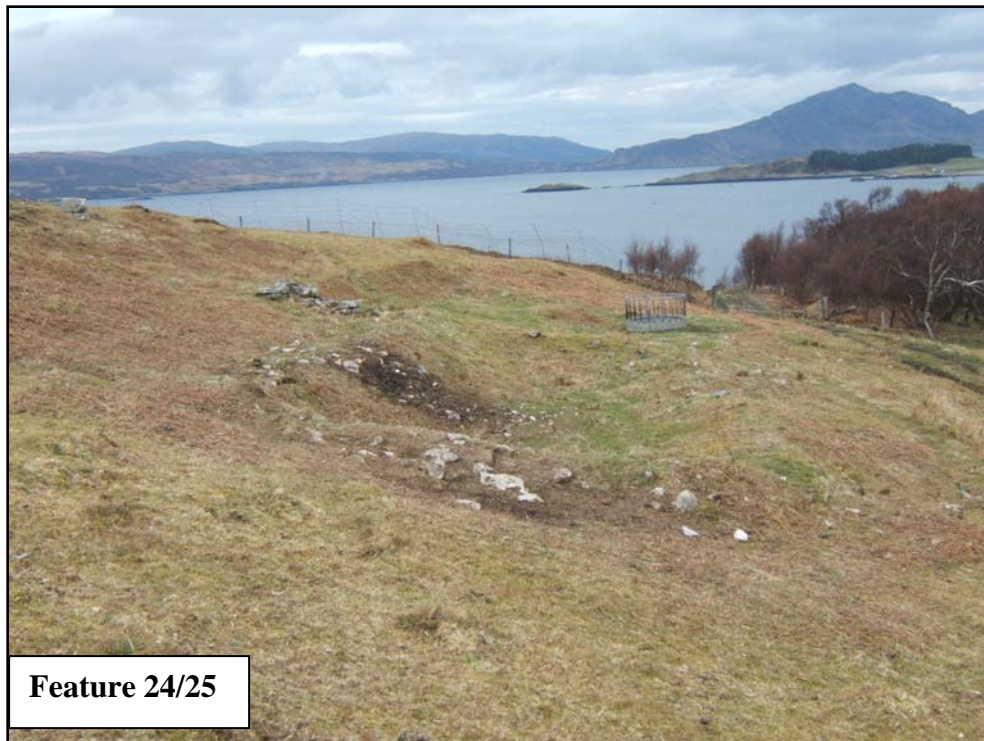
Not more than 2m to the southeast of Feature 24 are the ruinous foundations of what may have been a rectangular house. The structure, which has rounded corners, is lying northwest-southeast on its long axis and measures 11m x 5.50m internally with walls which are seen now as low raised banks with some stone showing through turf and grass. The southwest side of the structure has been dug into the hillslope and stands 1m high internally. There may have been an entrance 0.80m wide in the northeast wall. No internal features could be discerned.

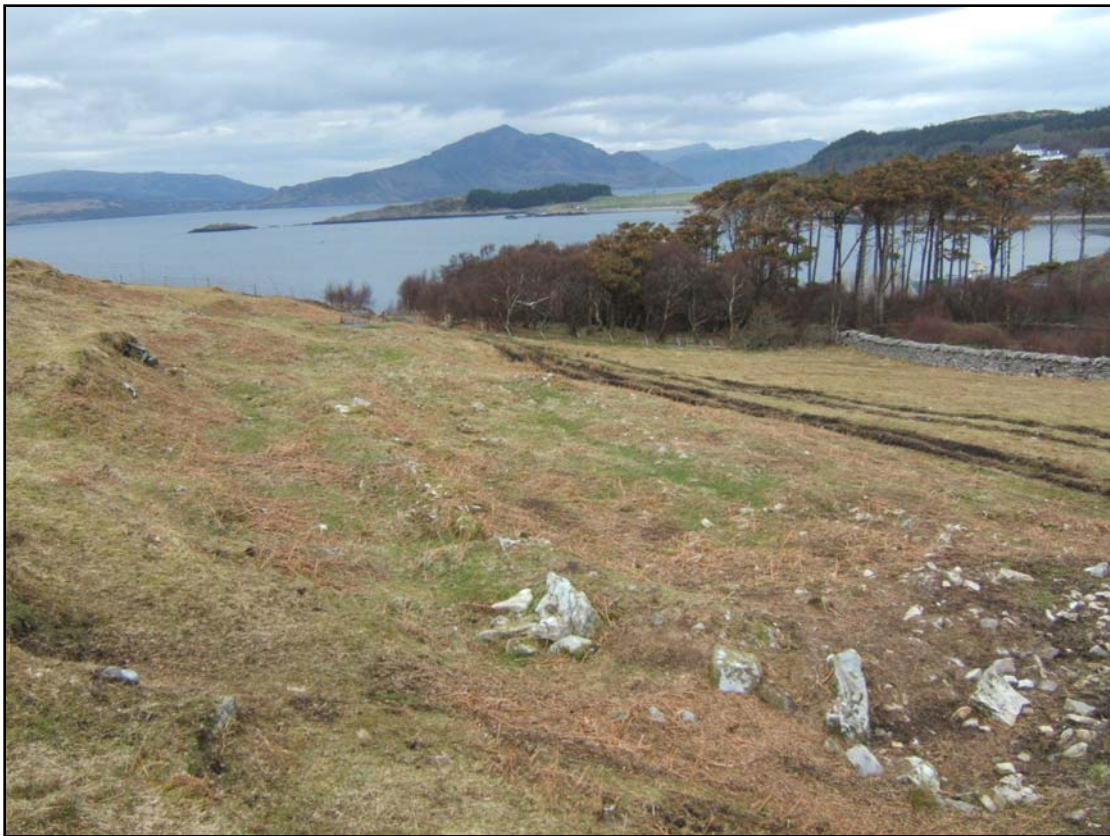
Feature 26

15m southeast of Feature 25 along the contour of the hillslope are the ruinous remains of what may have been a house with enclosure and kail yard attached. Lying northwest-southeast on its long axis are the foundations of a sub-rectangular structure 13m x 3.50m internally with rounded corners. The foundations consist of stone and turf banks standing to a maximum height of 0.50m and approximately 0.80m wide on average. The northeast wall of the house is destroyed for a length of 8m and it is not possible to say with certainty that this was where the entrance was although this seems likely. Attached to the north corner of the house a low stony bank runs west for 8m and then curves round southwards for 4m. At the west corner of the house another low bank runs for almost 4m to the foot of the steep hillslope at the southwest side of the house. These banks, the base of the hillslope and the northwest and southwest walls of the house define two enclosures, the more northerly being 7m x 8m at maximum and the southerly 12m x 4m. There may have been entrance between the enclosures in the bank at the west corner of the building.

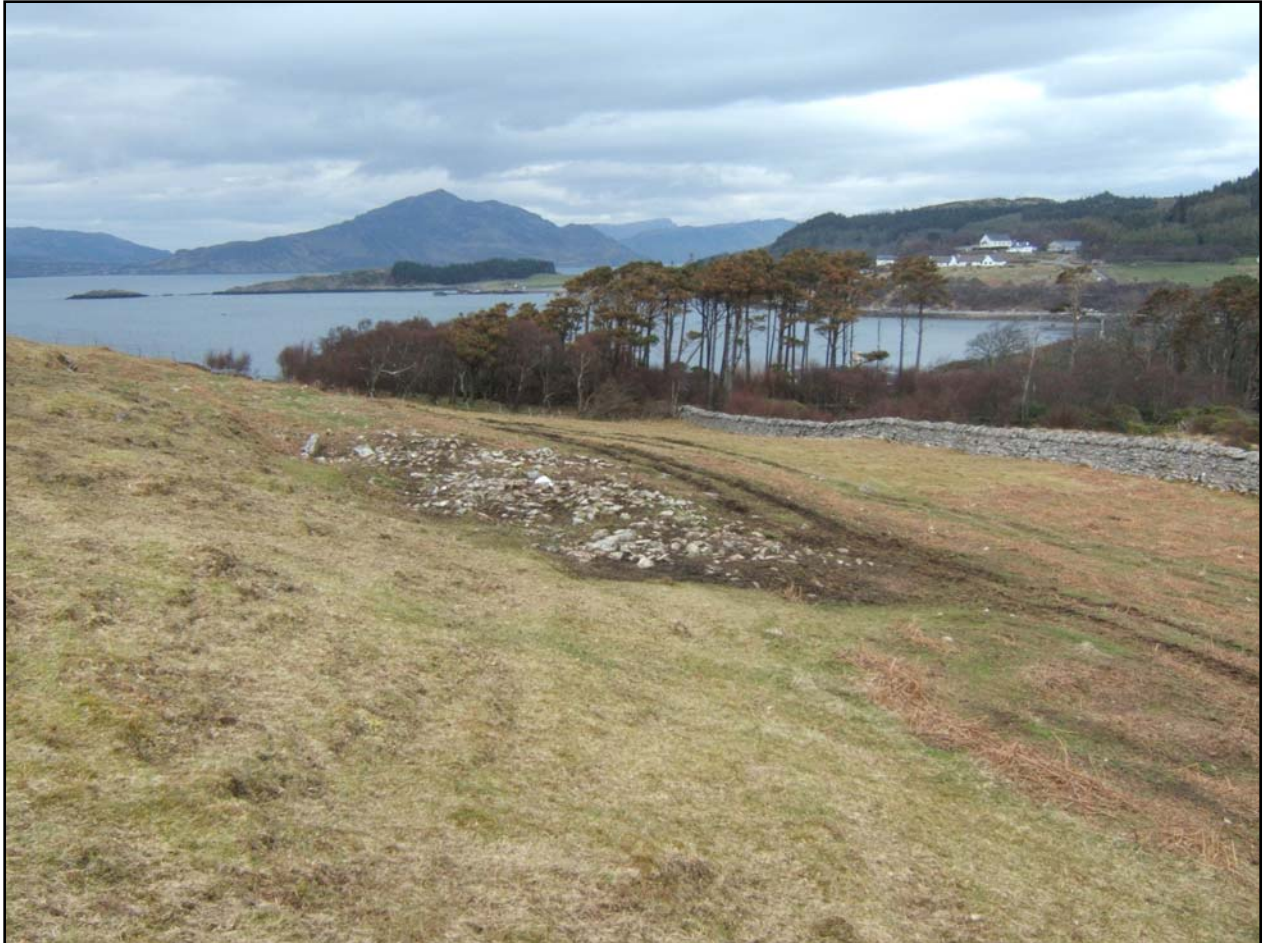
Feature 27

About 2m southeast of Feature 26 and lying northwest-southeast on its long axis is a sub-rectangular spread of stones 16m x 5m at maximum. The feature is completely covered with small stones. It was speculated that the feature has been a house which has been completely destroyed or alternatively has been a pile of stones gathered for the construction of the large enclosure close by to the east. It is possible that, given its shape and dimensions, this has been a house the base of which has been used to pile stones on for the building of the wall.

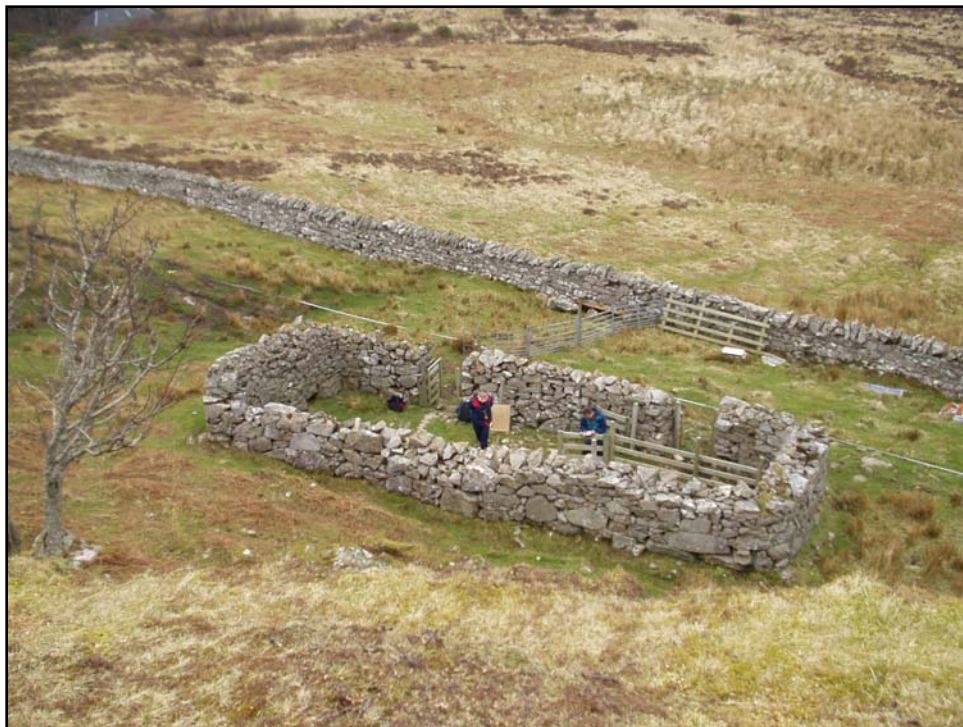
Some 2m southeast of Feature 28 are the upstanding remains of a rectangular house lying northwest-southeast and measuring 11m x 3.70m internally. The walls, which are 0.75m thick, are of dry-stone construction, double-faced with rubble infill, and stand to a maximum height of 2m. There may have been an internal partition seen now as a central pile of rubble. There are two entrances, 1m wide, in the northeast wall and there has been an earlier entrance, which has now been filled in, mid-way along this wall. In the southeast corner of the house is a modern wooden lambing pen approximately 3m x 2m

The structure indicates more than one phase of construction. The base of the building is built with large substantial stones while the stonework higher up the walls indicates poorer building techniques. It is thought that the later phase of the house's construction and use has either post-dated or is contemporaneous with the construction of the large enclosure and Feature 29 was probably built as a shepherd's house in the late 19th century when Suisnish was part of the great sheep farm which covered most of the south of the island.

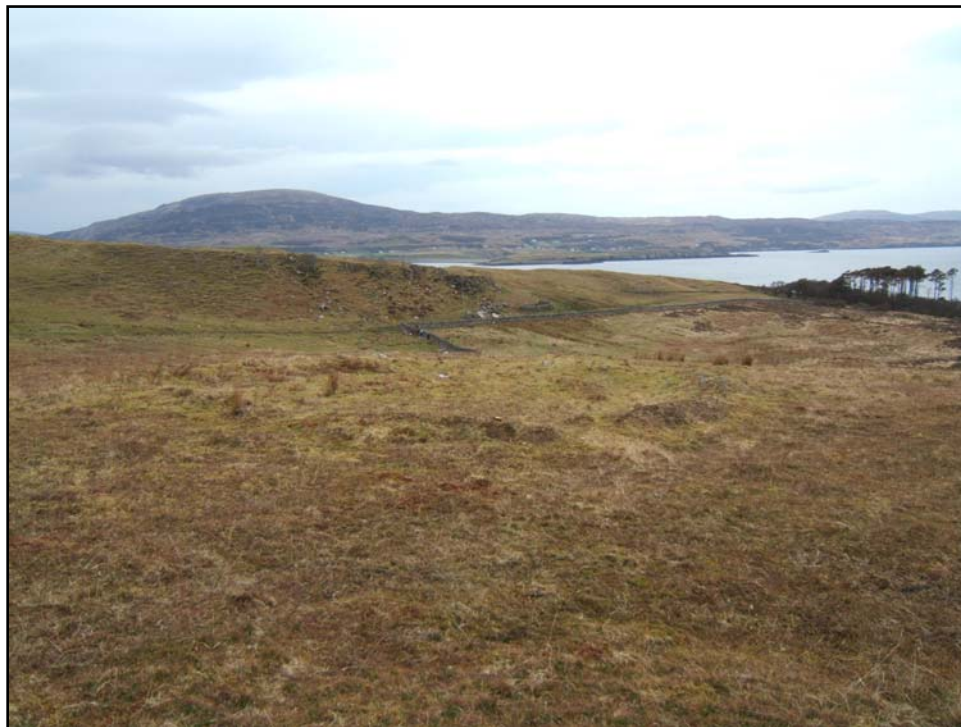
Feature 33

On a level, heather-covered area overlooking Suisnish to the west and south is a raised circular

turf bank between 0.70m and 0.90m wide and approximately 0.40m high with occasional stones visible. The bank encloses an area 10m in diameter, grass-covered in the interior and clear of stone. There are two breaks in the circle, one in the northeast sector and one in the southwest sector, either of which could have been the entrance.

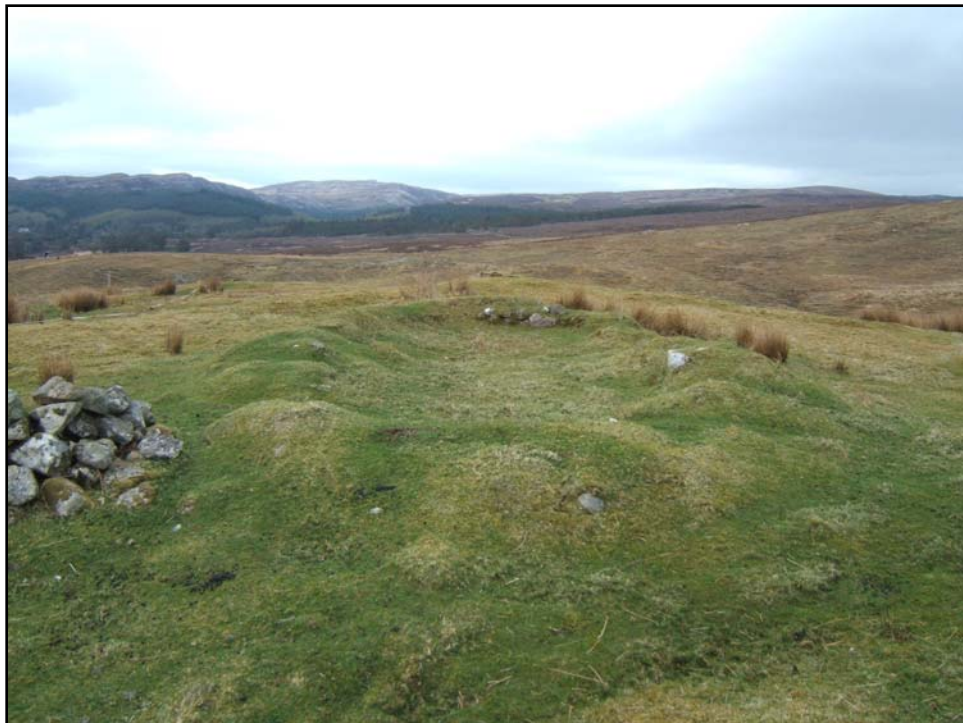
**Feature 39**

Lying northeast-southwest on its long axis are the remains of a house 9m x 4.40m internally with walling 1.10m thick and 0.60m high at maximum. An entrance 1.10m wide lies in the east wall. The structure shows as grassy turf banks with stone visible in places and a clear wall face can be seen at the northeast end. Both ends of the structure are rounded. There are no internal features visible.

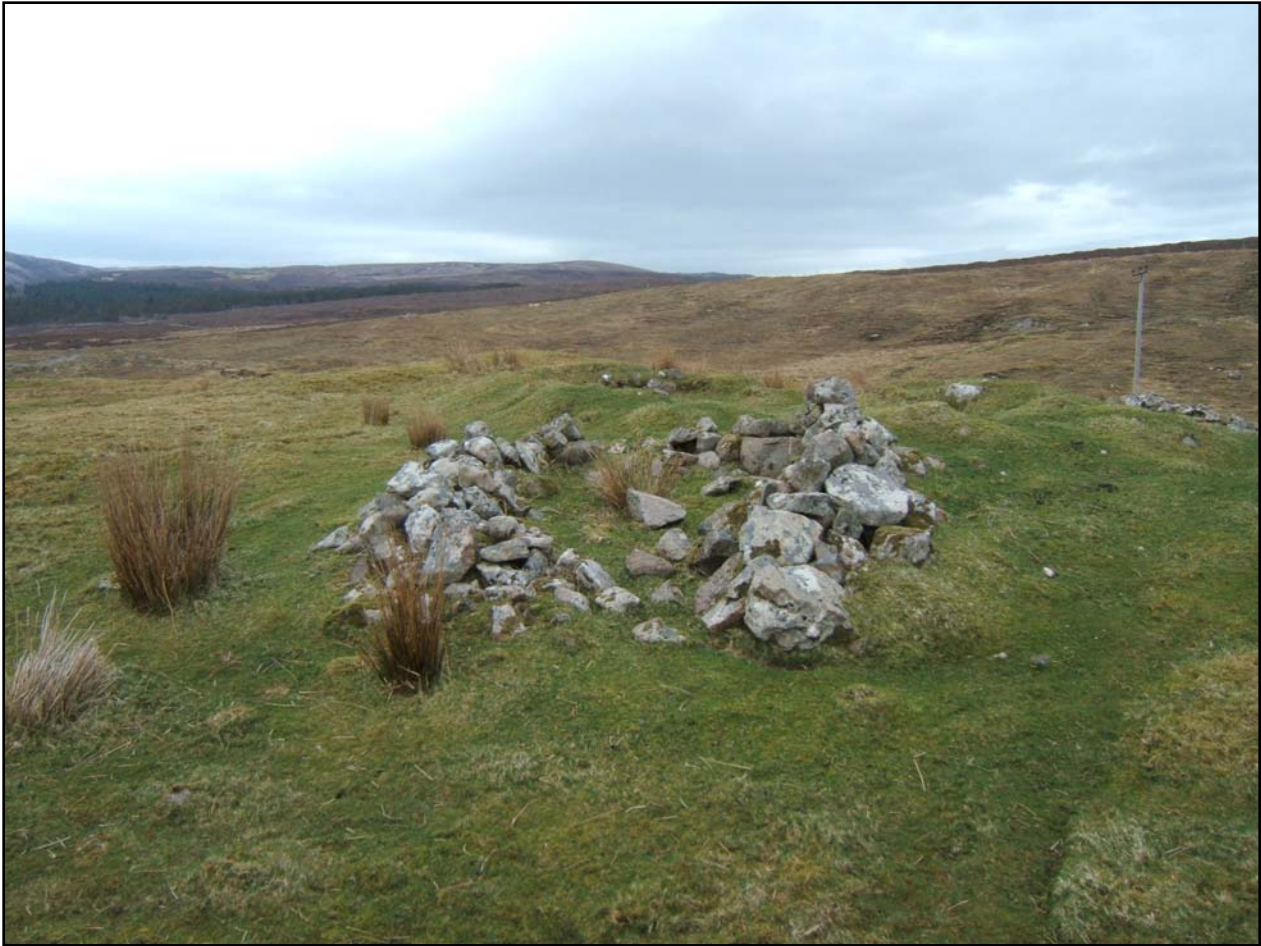
Feature 40

A small oval structure lies northeast-southwest on its long axis adjacent to the southwest corner of Feature 39. The structure has been rebuilt with rough boulders on top of earlier foundations. It measures 4.70m x 3.50m externally over walls 0.80m thick and 0.7m high at the maximum. An entrance approximately 1m wide lies at the southwest end.

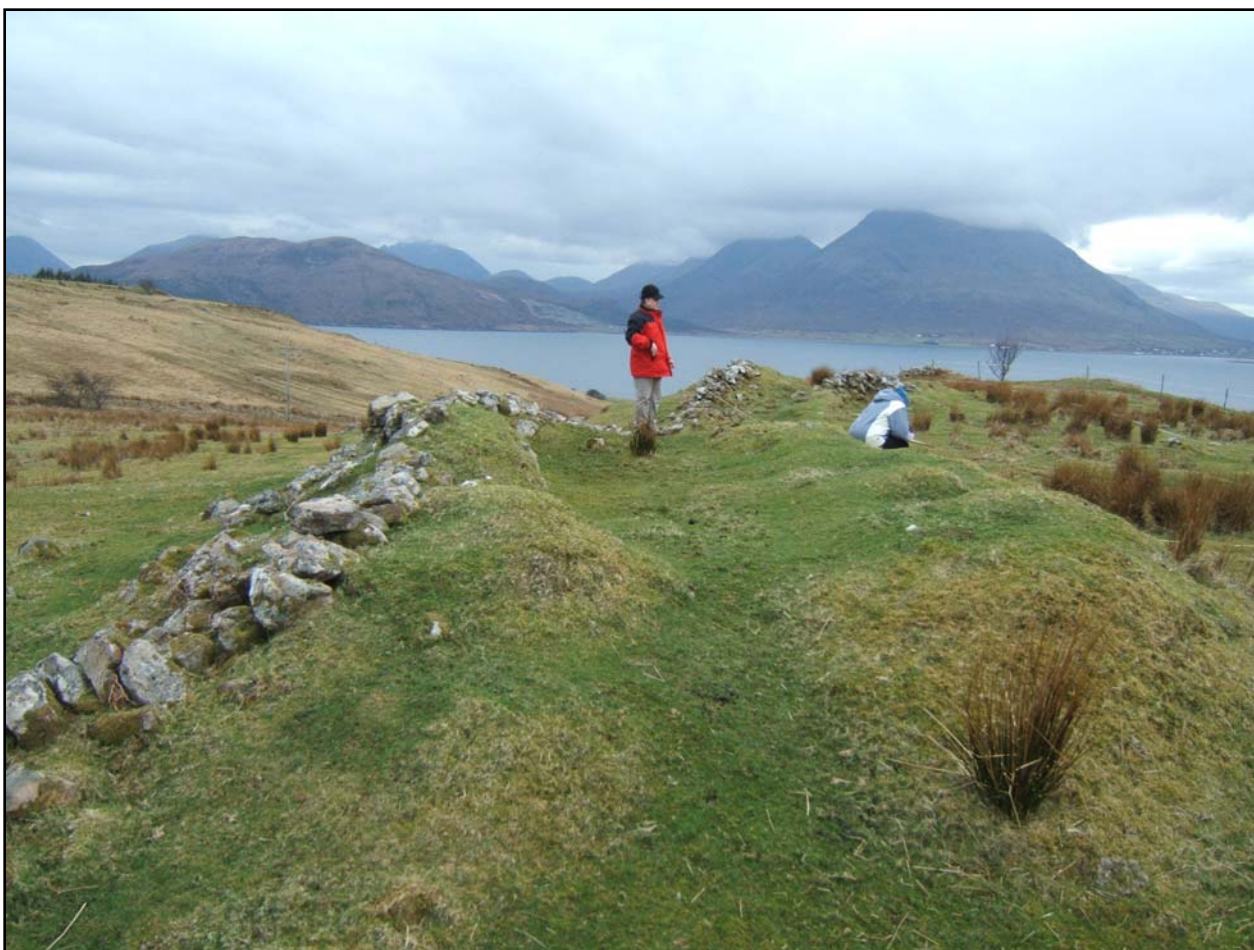
Feature 42

Lying northeast-southwest on its long axis 3m southwest of Feature 39 a round-ended house has had its east wall incorporated into the enclosing dyke. The house measures 9.70m x 4.80m externally over walls 1.20m thick on average. The walls show now as 1m high turf banks with stone showing through in places and the enclosing dyke is built on top of the southeast wall. There may have been an entrance 1m wide in the northeast end. The feature is grass covered with no visible internal features.

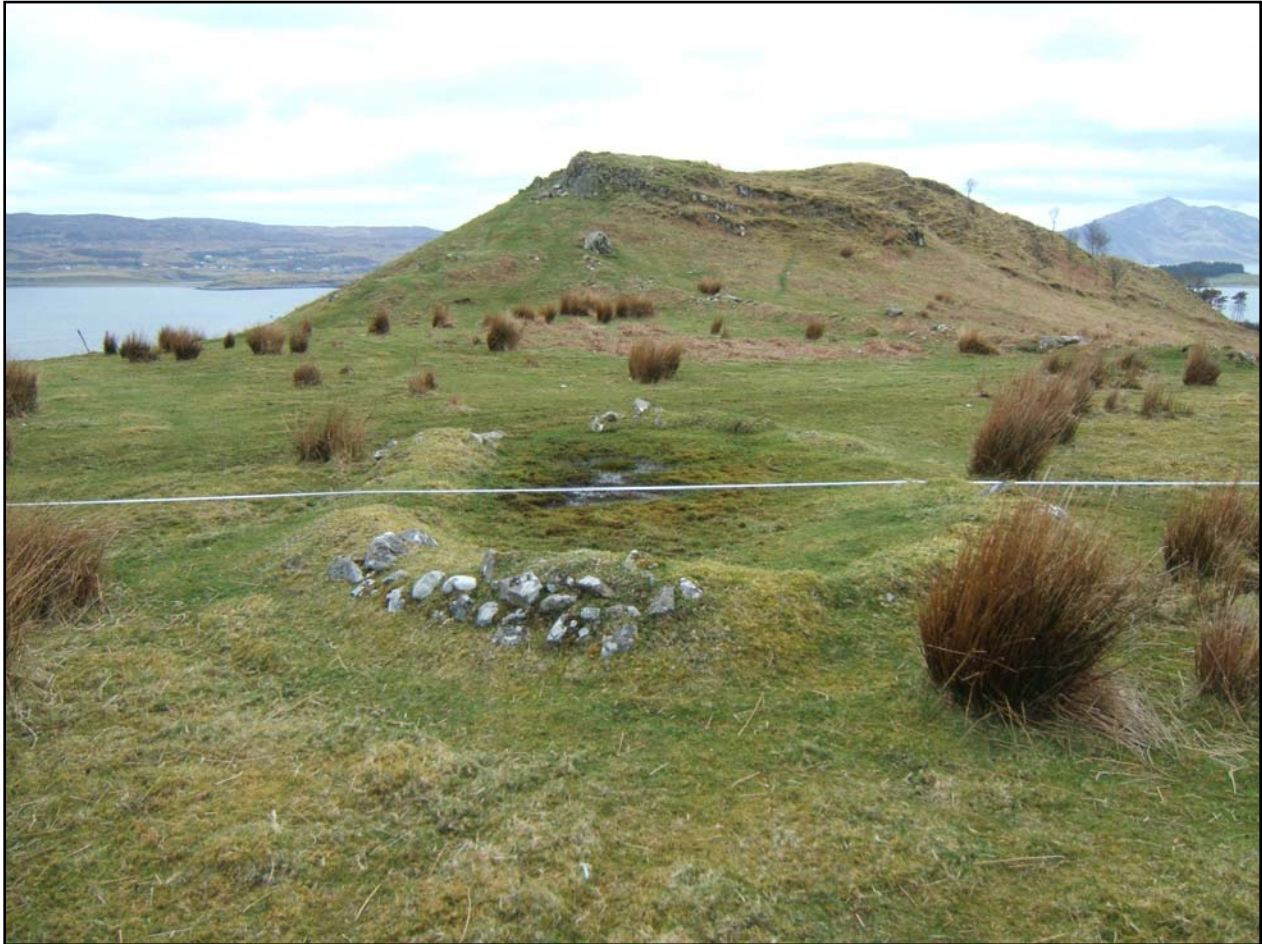
Feature 44

Lying northwest-southeast on its long axis 3m north of Feature 43 are the foundations of an oval structure 8.10m x 5m externally over turf and stone walls 0.70m thick. The grass and turf covered stone walls stand now to no more than 0.40m high. There may have been an entrance 0.90m wide in the south wall. The interior is very boggy and wet.

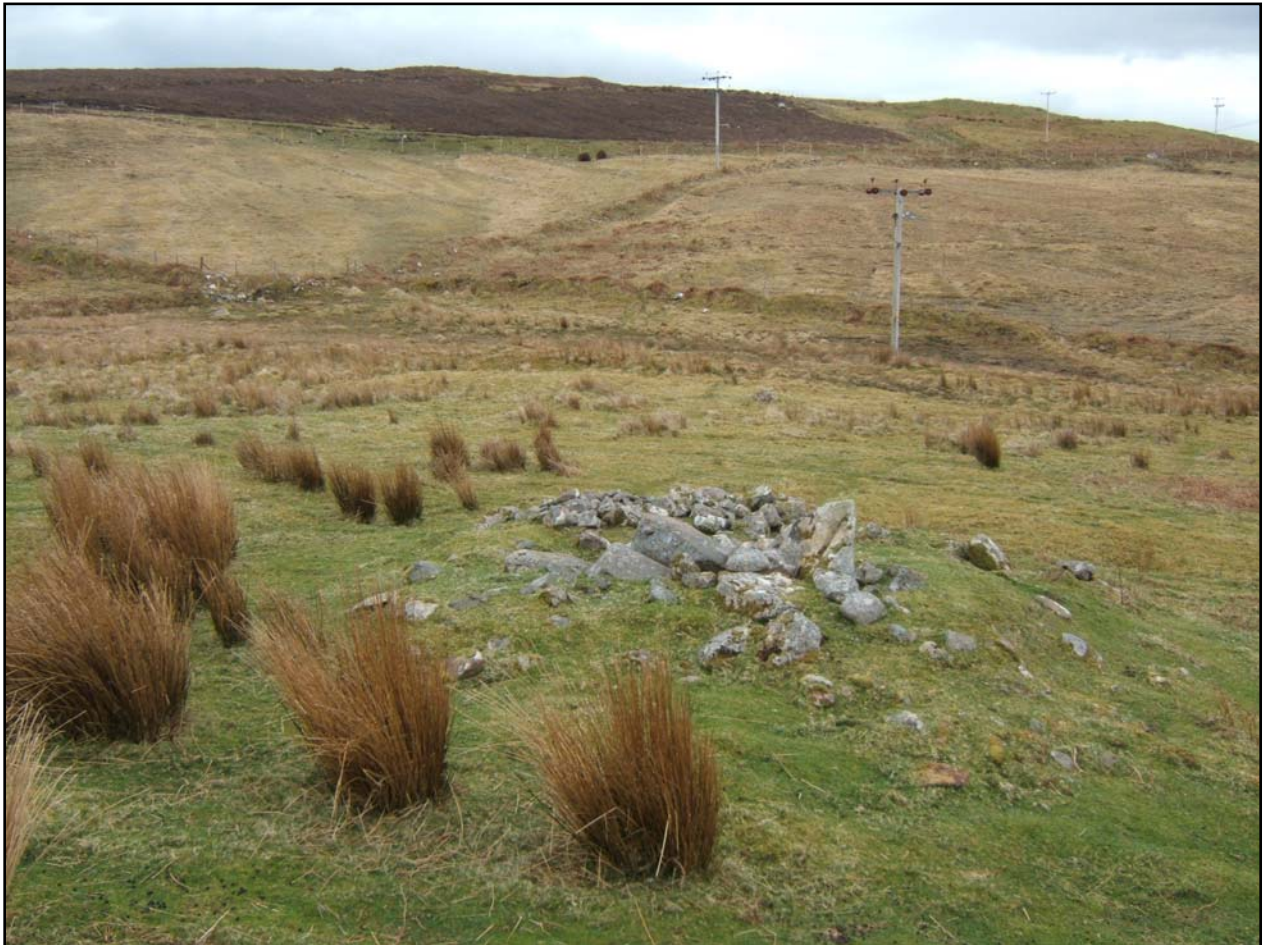
Feature46

that this feature is a robbed round cairn but the survey team, considering the fact that the large stones are piled on top of small stones and considering that there were signs of wall facings at the north wall, came to the conclusion that the feature was an old byre later used as the basis of a clearance cairn when the area around was cleared and improved.

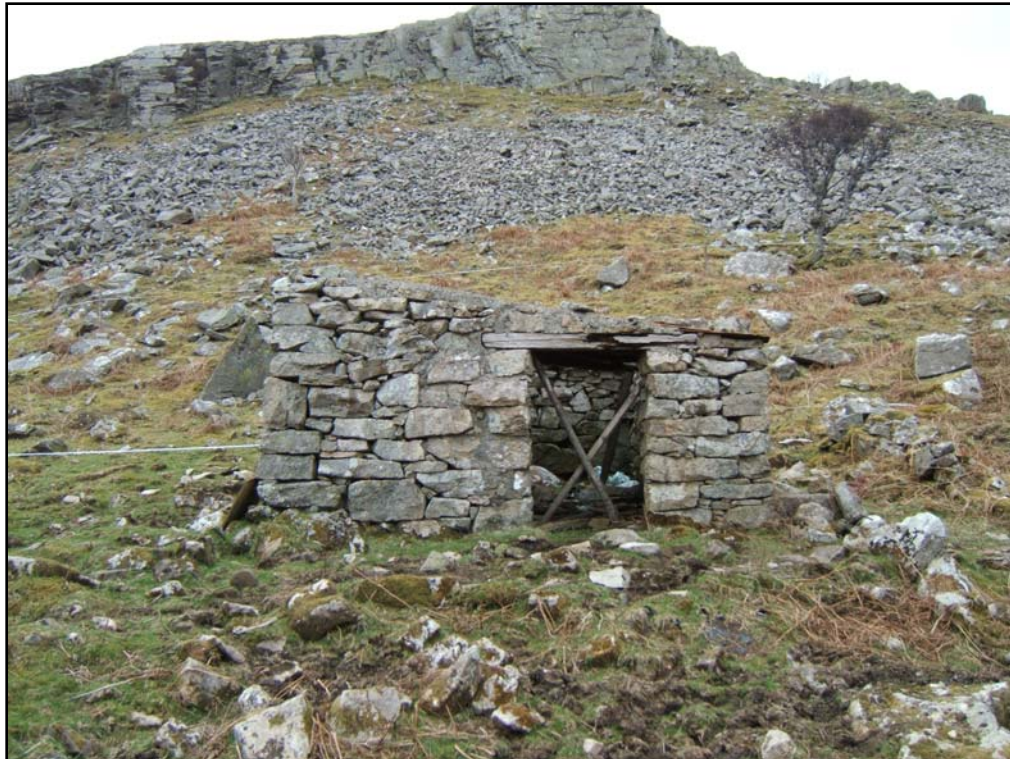
Feature 47

A sub-rectangular dry-stone structure (known as the Bull House) lies at the foot of a steep scree-covered slope at the southeast extremity of the site. The structure faces southwest over the Sound of Raasay some 130m northeast of the Magazine House (on the OS map). The walls are of varying lengths giving an internal area of about 2.60m x 3m. The walls are double faced stone with rubble infill. They are 0.60m thick standing to 2.10m at the north end and sloping to 1.60m at the south end. The southwest wall has been mortared in places around the doorway which lies 1m from the southwest corner. The doorway is 1m wide and 1.50m high with a

wooden lintel, 1.70m long, 0.30m high and 0.12m thick, remaining in place. The lintel has the appearance of a railway sleeper and the site is no more than 300m from the iron work lines. Four joists in the ceiling made of rough tree trunks are crossed by four thin wooden slats on which are laid sheets of corrugated iron weighted down with heavy stones. At the southeast end of the structure low tumbled walling extends out to form an extension 1.60m northeast-southwest x 4m southeast-northwest which has probably been open at the southwest side. This may be the old founds of a larger structure which has been rebuilt into the present building or the base of a cart stand.

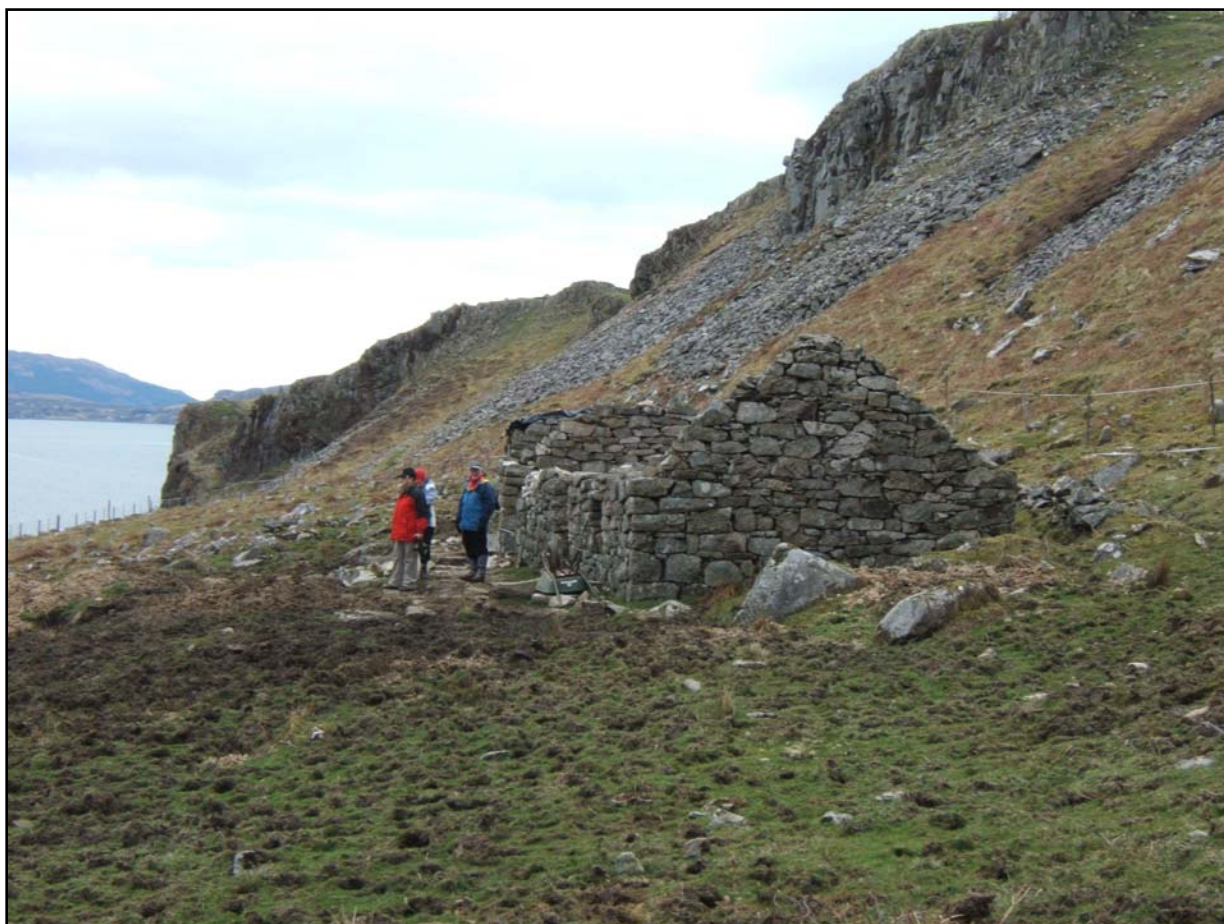
At the foot of a rocky, scree-covered slope about 5m northwest of Feature 48 a rectangular structure lies northwest-southeast on its long axis. The building measures 9.50m x 3.50m

internally. The walls are double faced dry-stone with rubble infill and are 0.65m thick. They appear to be standing mostly to the original height – about 1.50m on average. The short walls have intact gables, the southeast 3.50m high and the northwest almost 3m as some of the apex has fallen. There are two doors, both 1.20m across, in the west wall, one in the northwest corner and one 3.50m from the southwest corner. There have been two windows in the west wall, both now blocked up. Internally there is flagstone paving in the northwest end which may have been a drain for a byre and there is some paving against the west wall at the southeast end. The floor of the building where there is no paving is hard packed earth and gravel. Outside the west wall of the building an area 2.50m wide has been paved with large slabs. At the rear (east) side the sloping ground has been dug out for about 1m to form a ditch along the back of the structure and an arc of rough boulder walling is set along the contour roughly 1m from the edge of the ditch. The feature is now being used as a stable for 2 horses. A narrow path, flagged in places, connects Feature 49 with Feature 50.

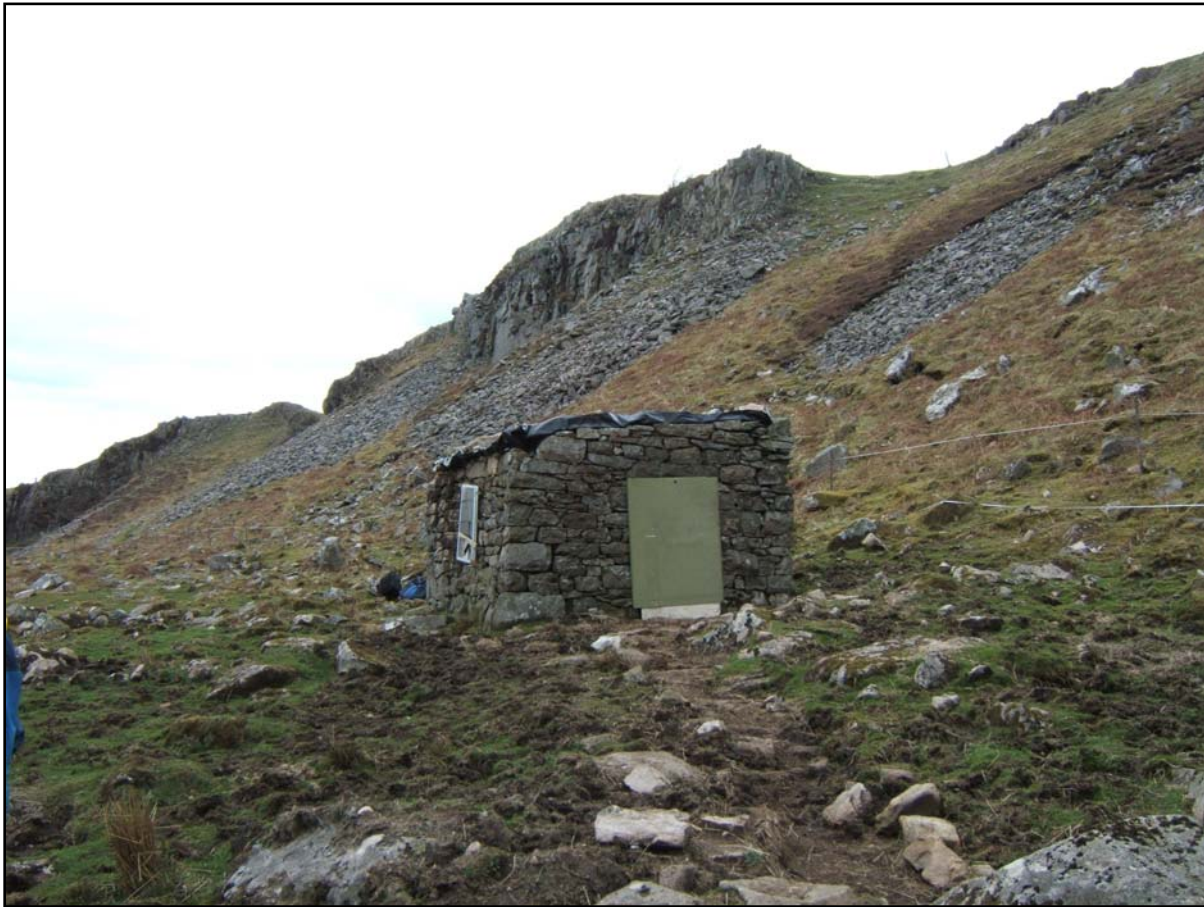
Approximately 10m northwest of Feature 49 is a rectangular structure 4.20m x 3.20m externally over walls about 0.50m thick. The walls are of dry-stone construction and stand 2.50m high at

the east and 2m at the west with a flat roof of corrugated iron held down with large stones and fixed to rough tree branches which act as joists. A door 0.80m wide and 1.50m high stands in the middle of the southwest wall and a window 0.50m wide and 0.70m high lies in the middle of the west wall. The building is presently used for storing hay. At the northwest end of the structure is an irregular area about 2.50m square which has been paved with large flat stones. In front of Feature 50 can be seen the remains of an enclosure running northeast-southwest and measuring 27m x 7m bounded by stone and turf banks, partly rebuilt in more modern times. The enclosure walls have clearly been rebuilt and modified over the years and it is possible that there may have originally been several smaller enclosures on the site. The structure at NG 5534 3489, shown on the OS map, no longer exists although a stony platform, 5m x 4m, which lies against the inside of the southwest wall of the enclosure, is probably the base of it.

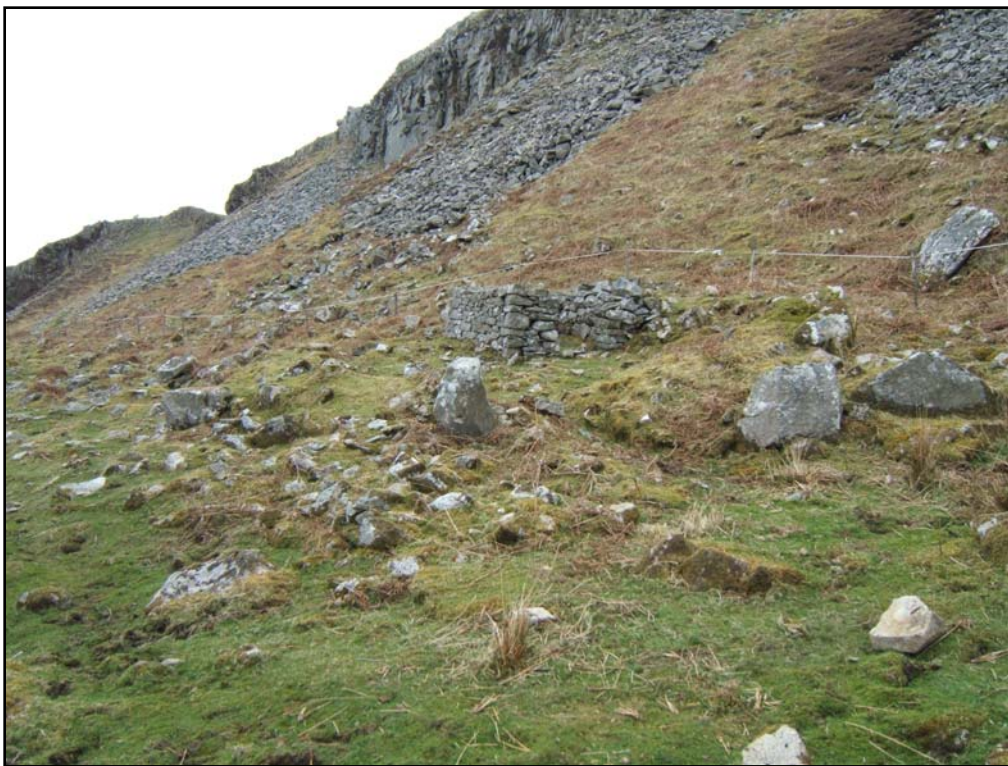
Feature 51

As the area of the site begins to narrow at its northwest end an enclosure has been built at the base of the steep scree slope. The oval enclosure, 10m x 7m at maximum, is bounded by a bank of stone and turf with some very large stones within it and there is an entrance, 1.30m across, at the south end. The enclosure is now very ruinous but clearly discernible for the most part. In the north end of the enclosure, built into the slope, is a small rectangular barn of double-faced drystone construction with rubble infill. The structure measures 2.80m x 1.90m internally and has a doorway 0.80m wide in the centre of the short southeast wall. The walls are 0.60m thick and stand to 1.40m high, thought to be their original height. A very large stone is built into the northwest wall. There is no indication of any roofing, unlike the other structures on the site which appear to be contemporaneous.

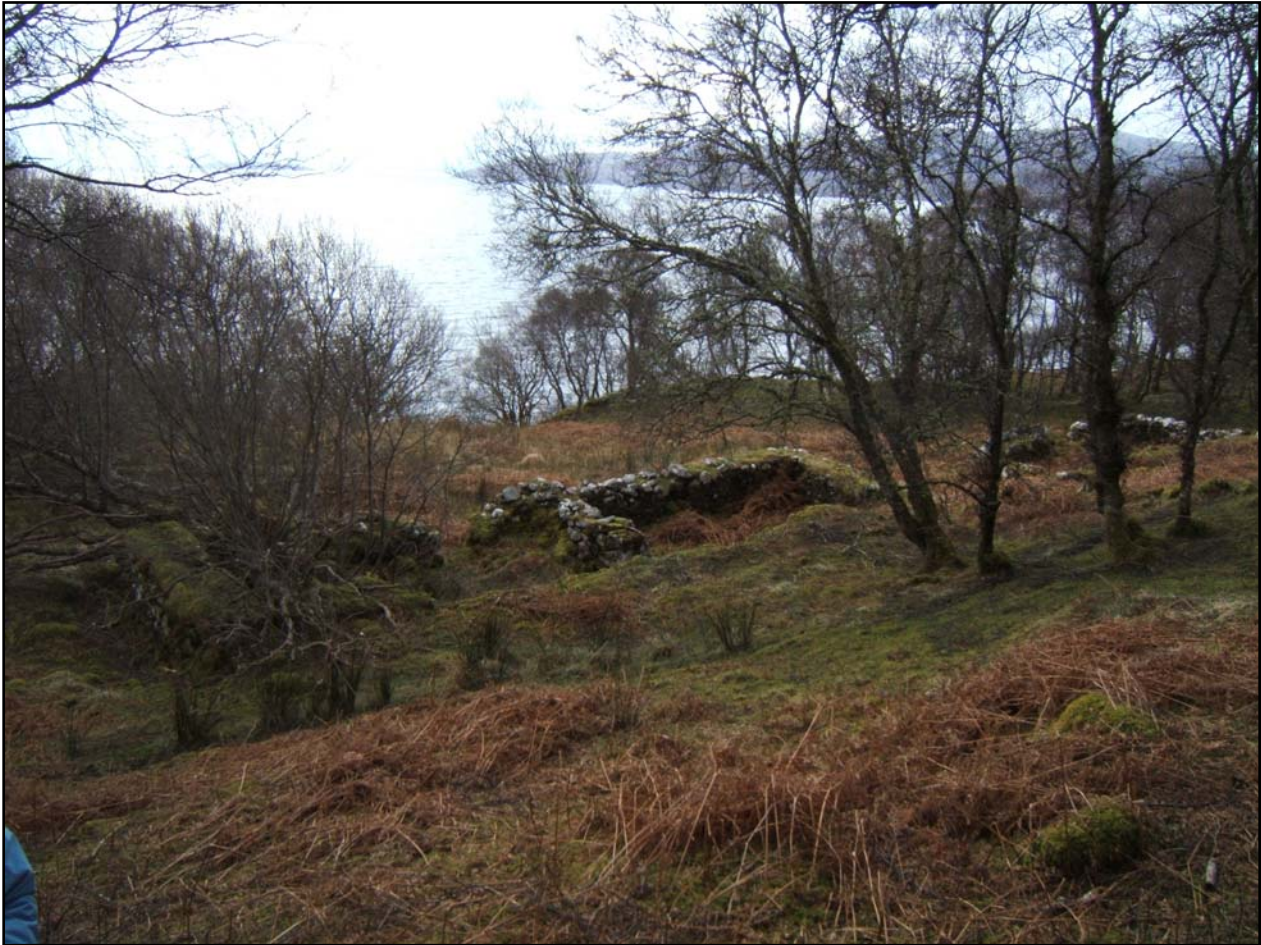
Feature 12a & b

In the woodland at the lower east side of South Fearn are several upstanding structures with an enclosure and field. Feature 12a lies northeast – southwest on its long axis and measures 7.40m x 3.00m internally. The walls, which are of rough drystone construction with some tooling evident, are now turf covered and stand to an average height of 1m and are 0.80m thick. There is one entrance 0.80m wide in the centre of the southeast wall, with a sill stone still in place. The corners of the building are rounded externally and internally with squared foundation stones underlying the corners. There are no windows visible and no sign of a fireplace or any internal partition. There is a possible cruck slot in the northwest wall opposite the door. An apron of

6m to the northeast of Feature 12a is a long upstanding structure lying northeast – southwest on its long axis. The structure measures 12.80m x 3.90m internally with an annexe, 4.40m x 4m, built on the northeast end but not bonded to the main structure. The annexe has an

entrance in the south corner of the southeast wall. The external corners of the house are rounded and are built of large foundation stones. There is an entrance 0.90m wide roughly midway in the southeast wall. The house is divided internally into 2 compartments by a drystone partition wall 3m long and 0.60m wide standing to a height of 1m which has been butted on to the southeast wall 1.20m southwest of the entrance. The partition divides the structure into 2 compartments, the south compartment being 5m long and the north 6.90m long, with access between the compartments in the northwest. In the south compartment there may have been a recess with a lintel stone low on the south side of the partition wall and in the northeast compartment a stone platform 1m x 1.2m lies between the entrance and the partition wall. The east corner of the north

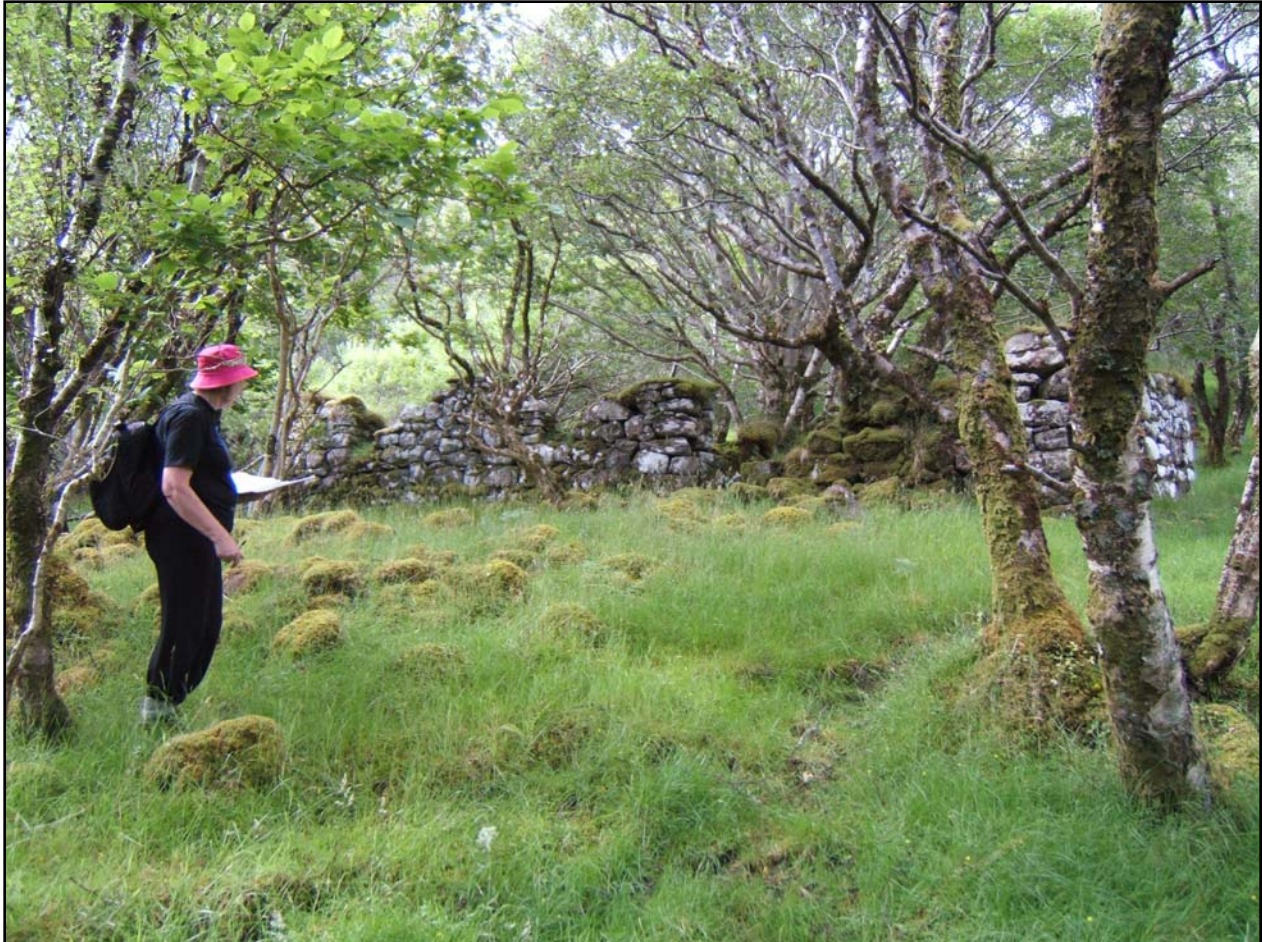
Immediately adjoining the house at its southeast corner are the low foundations of a sub-circular enclosure of rough boulder construction, approximately 7m x 5m, the northeast end of which may have met the southeast corner of the house.

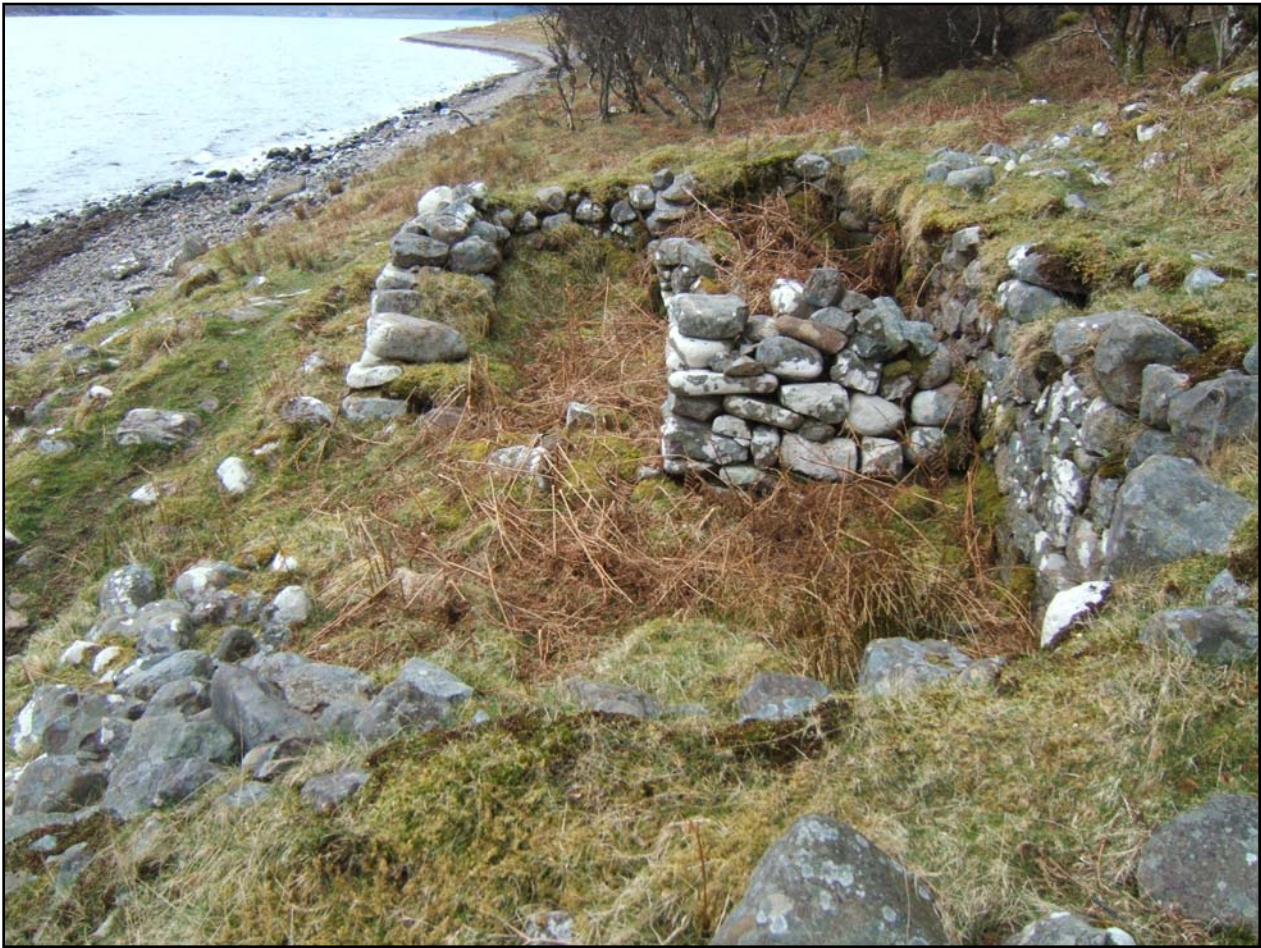
The feature lies just above the beach on the edge of an un-named burn and at the foot of a slope amid birch and hazel trees. The ruins lie in a clearing 14m southwest of the burn which may have been diverted from the nearby gully by a drystone wall about 1m high and 0.80m wide. The structure appears to be 2-celled and the southwest cell may be older than the northeast and lie partially underneath it. The northeast section measures 6m x 3m internally and the southwest section measures 5m x 4m internally. There are two internal walls in the northeast section which have been inserted at a later date to form a small pen 2.80m x 1m with an entrance in the east corner. The house is of drystone construction with rounded external corners and square internal corners. There appears to have been an entrance into each section on the sea-facing walls. There is a considerable amount of tumble both inside and outside and some stone lying in front of the northeast section may have been part of earlier foundations.
