An Archaeological Survey
of the townships of Suisnish and South Fearn
plus the surrounding area.

Raasay

Portree Parish
Skye and Lochalsh District, Highland Region

Association of Certificated Field Archaeologists
Occasional Paper No 80

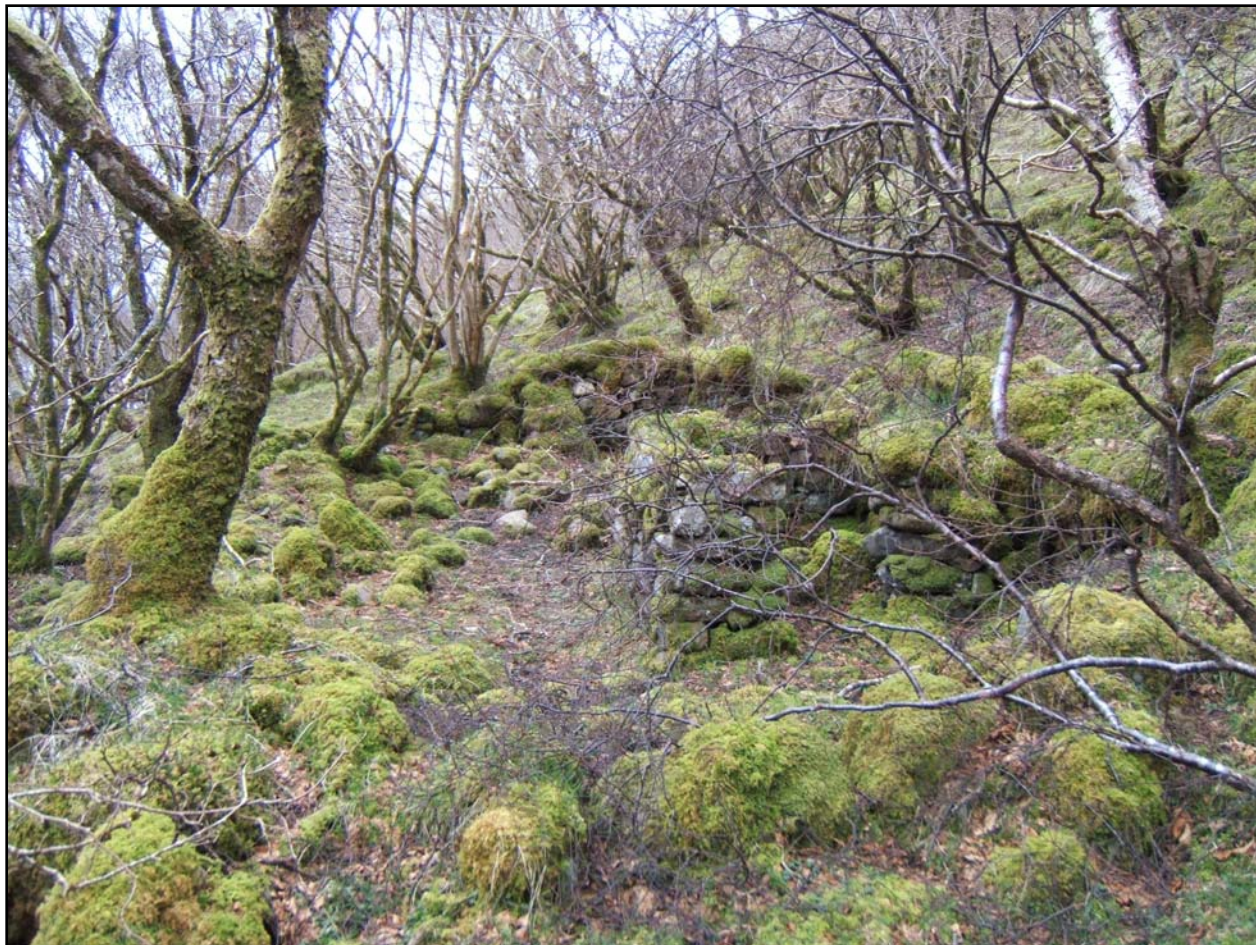
A ruinous house lies amid birch and hazel trees 10m inland from the shore line and 200m northeast along the shore from Feature 17. The house, of drystone construction, measures 9m x 4m internally with walls standing to a maximum height of 1.40m and between 0.60 and 0.80m thick. There is an entrance 0.80m wide towards the northeast end of the east wall facing the sea. The corners are curved externally and square internally and the walls are now moss covered. A short stretch of wall 1.50m long has been butted on to the inside of the southwest wall. A pen, 2m x 1.50m, has been inserted into the building by butting walls, uniformly 1.20m high, on to the northwest wall. An entrance to the pen lies in the north corner. A section of the back wall has been removed, probably to build this pen. The front wall of the house is now completely ruinous. A path from Fearn's to Eyre passes immediately in front of the house. On the other side of the path a small area is bounded on 3 sides by a tumbled wall which is 8m on its long side and is open to the sea.

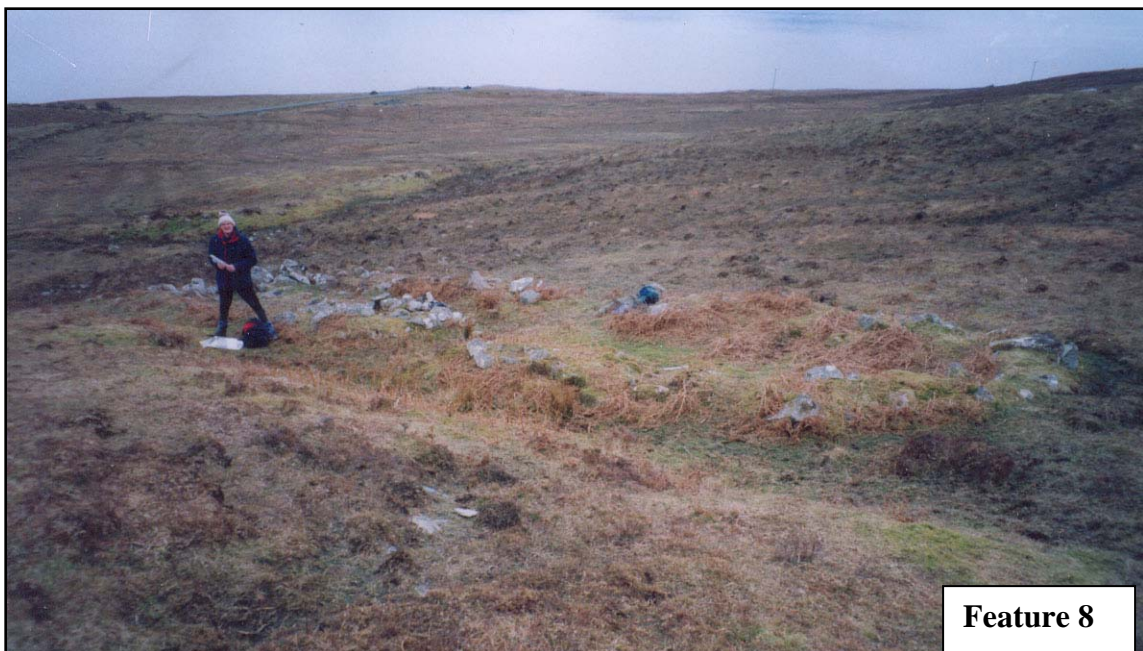
Lying north-south on its long axis on a south facing slope are the remains of a long house, 14.70m x 2.80m internally. The stone built walls are tumbled and covered with bracken but are clearly visible standing to a height of about 0.40m and a width of 1m on average. Both ends are

bowed and there are two entrances 1.20m wide in the centre of the east and west walls. A clear partition wall divides the structure into two parts, the smaller part, presumably the byre, being at the downslope end. A more recent modification at the northeast corner forms a probable lambing pen, 1.30m x 1m.

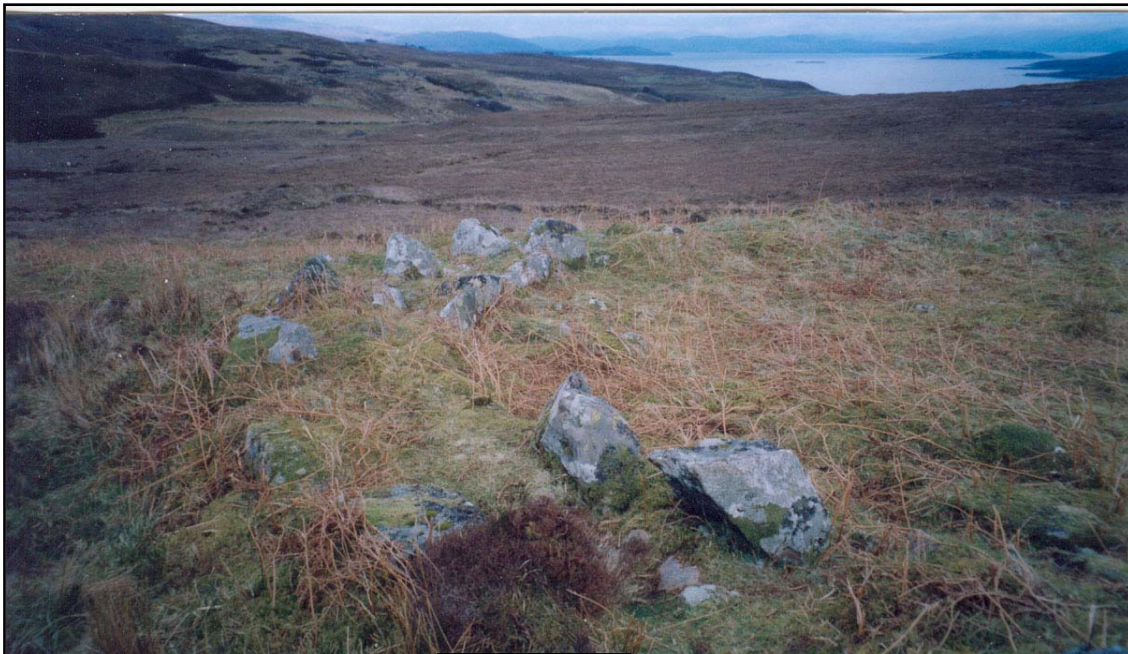
On a levelled platform at the top of an east facing slope are the remains of a hut circle approximately 8m in diameter. The base layer of the double-faced stone walls remains clear over 240 degrees of a circle with the east sector indistinct. The walls, well faced with large stones and infill of small stones and turf, stand now to a height of 0.40m and are 1.20m thick. There is no sign of an entrance but it probably lay in the east sector which is now more poorly defined. No internal features are visible. The circle is close to and overlooks an enclosure on its east side which is shown on the OS map.

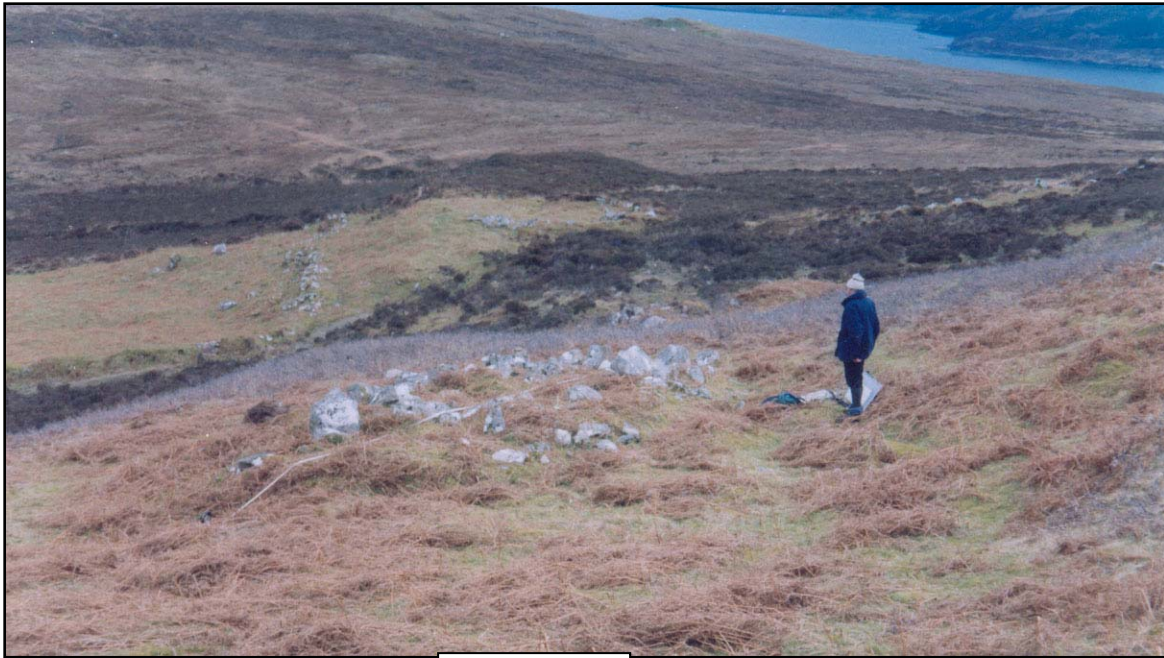
Situated on an east facing slope in a shallow bowl some 20m to the north of Feature 9 a sub-rectangular structure lies almost obscured by moss and bracken. The structure is in two parts, the larger section to the east being 5.20m x 4.80m internally and the smaller section being very irregular and approximately 2m x 2m. The rough stone and turf walls are on average about 0.50m high and vary in thickness from 0.70m to over 1m. There may have been an entrance more than 1m wide in the southwest corner.
